# Roof Condition Report

Prepared by Prysm Spatial Imaging Inc.

## Sample Client Report

123 Sample Road, Prince George, BC

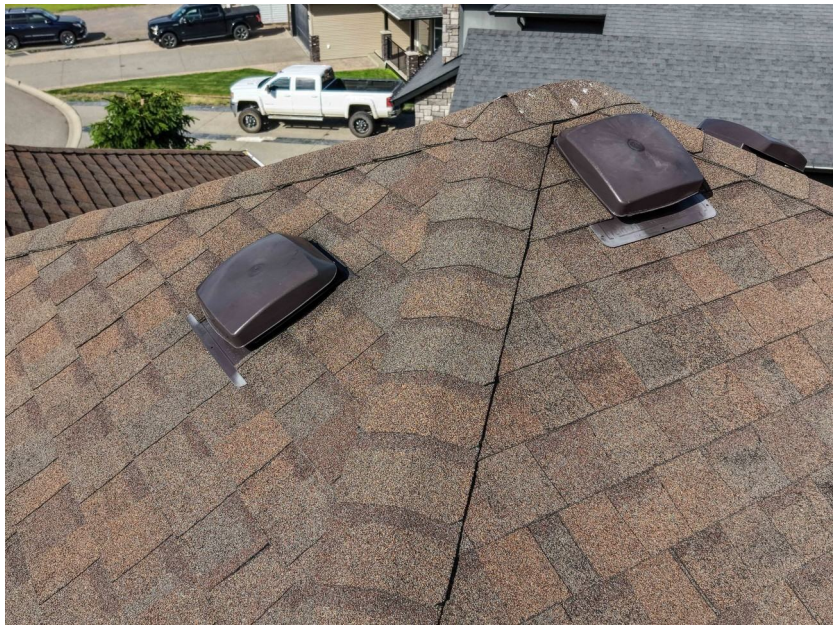
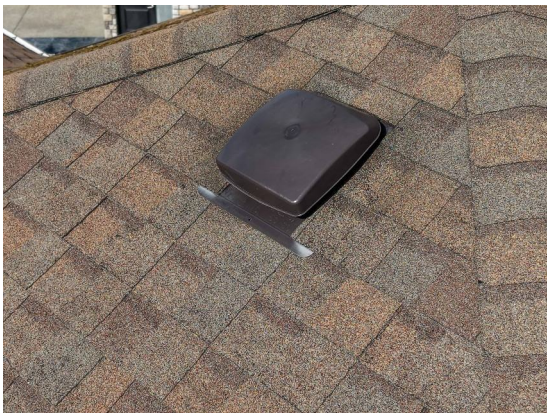
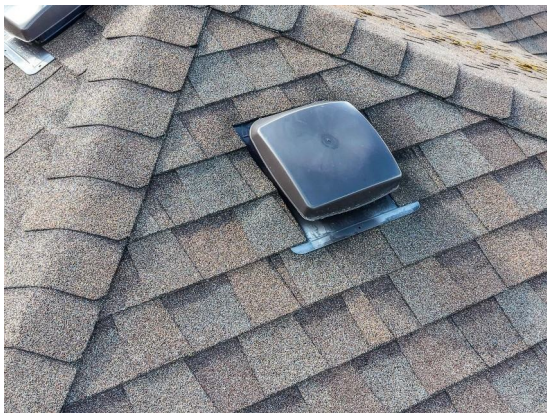
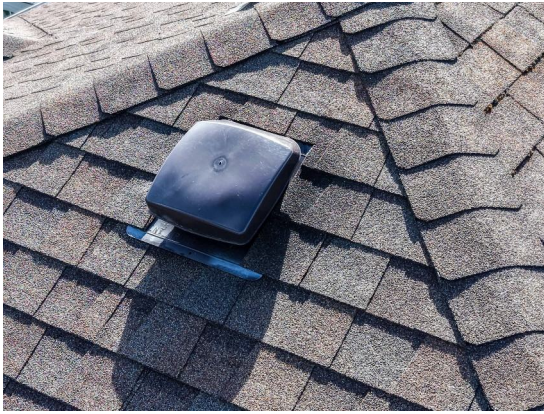
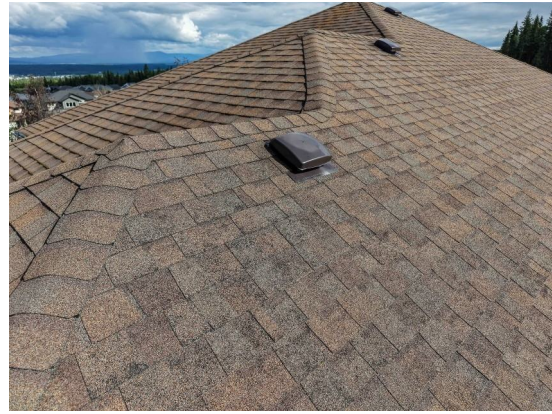
Documented five (5) roof vents located along the ridges of the roof with three (3) located at the peak. All appear to be in good visual condition with overlapping roofing material in tact.

Continue to monitor condition as part of routine/annual roof maintenance.

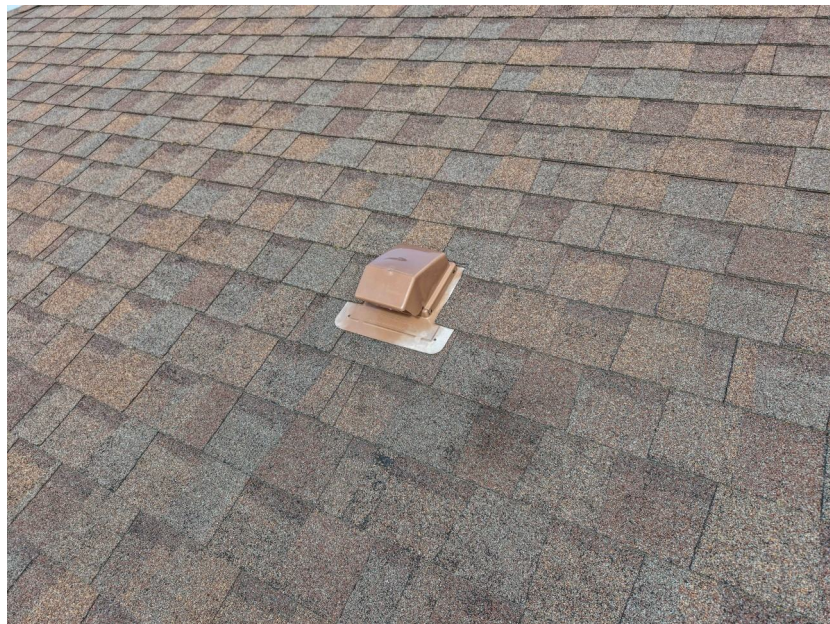
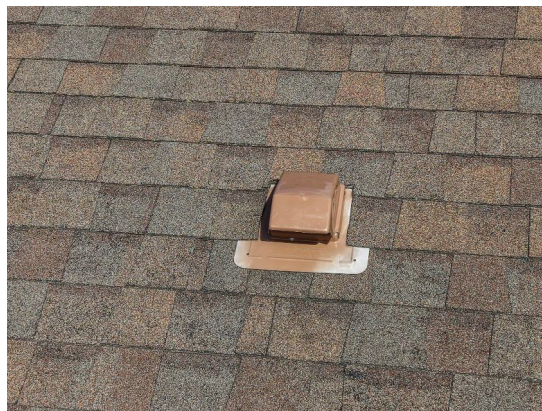
Observed two (2) vents on lower portion of the south and west roof faces. Both appear to be in good visual condition with overlapping roofing material in tact.

Continue to monitor as part of routine/annual roof maintenance.

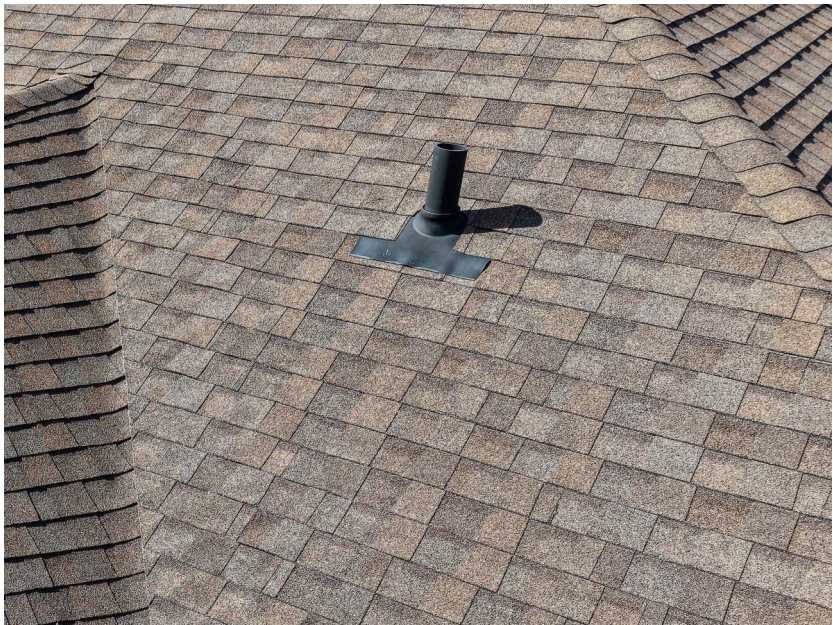
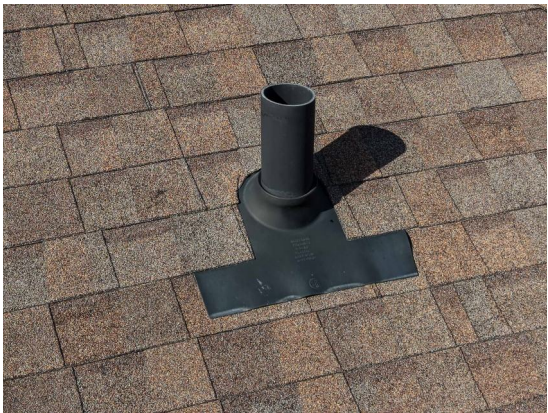
**Observation**  
Plumbing vent appears to be in good visual condition with overlapping roofing material in tact.

**Recommendation**  
Continue to monitor as part of routine/annual roof maintenance.

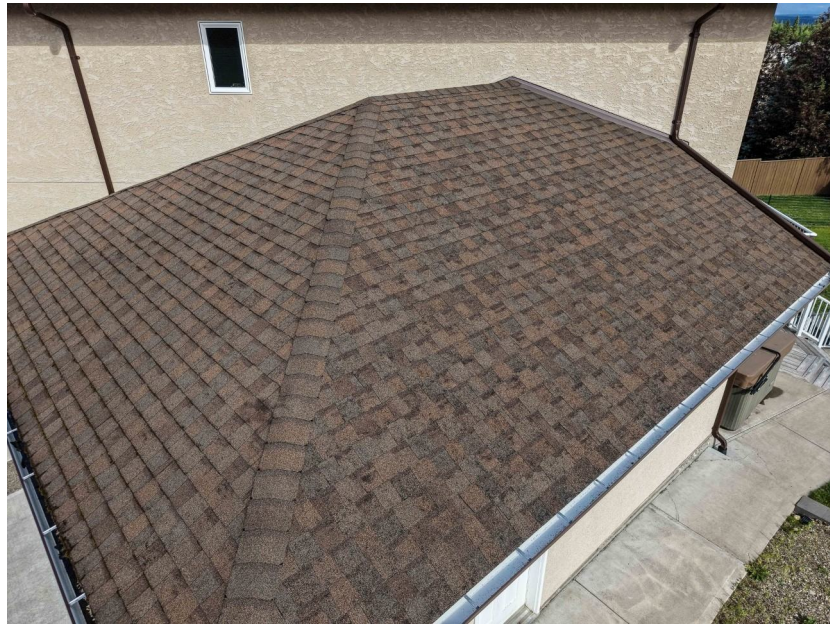
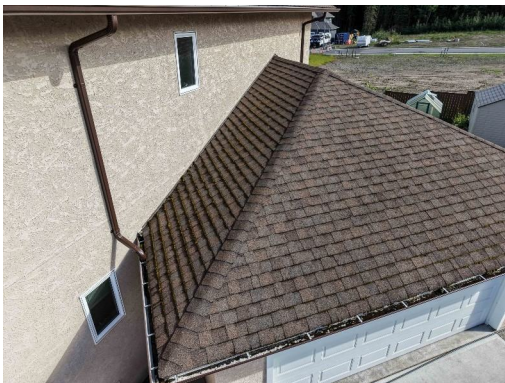
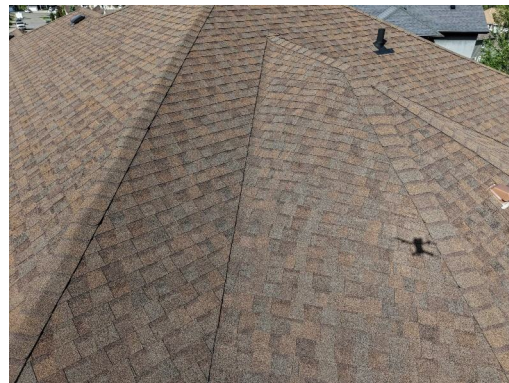
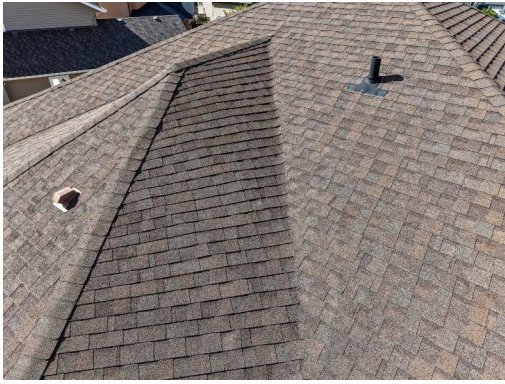
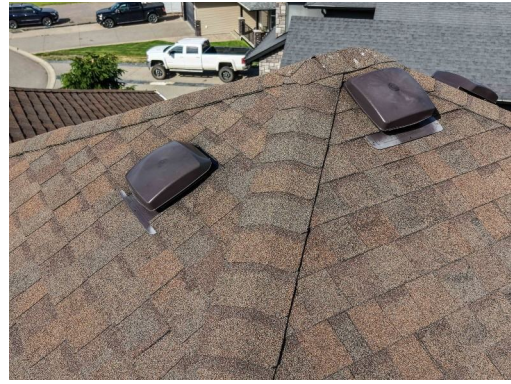
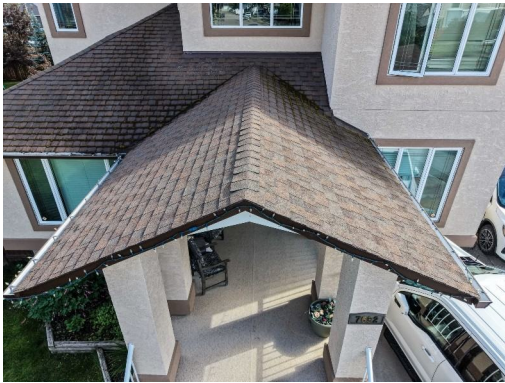
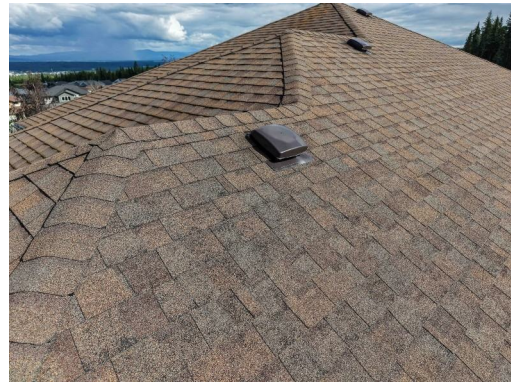
Ridge caps and valley overlaps appear to be in good visual condition across upper portion of the roof. Refer to Moss Growth observations for evidence of moss growth observed on north-facing valleys.

Continue to monitor for wear and moisture infiltration risks as part of routine/annual roof maintenance.

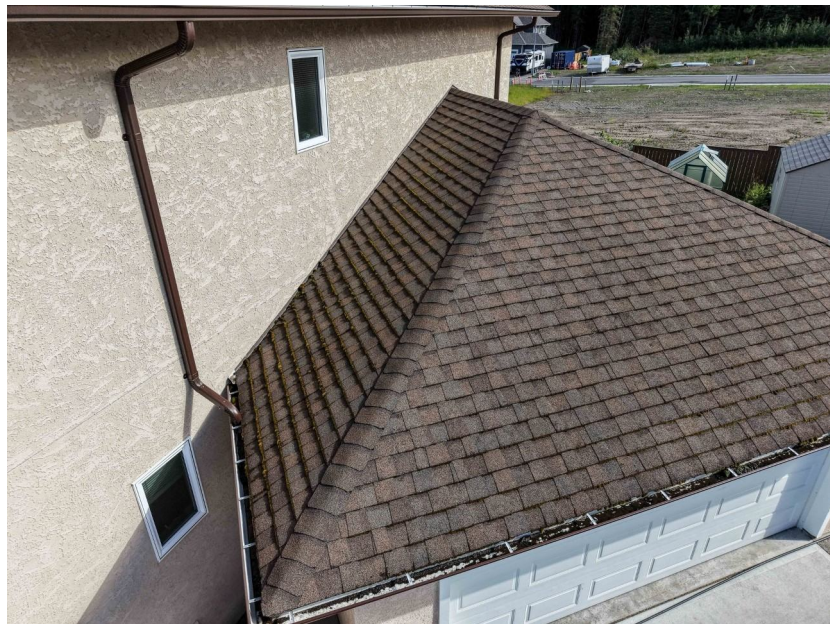
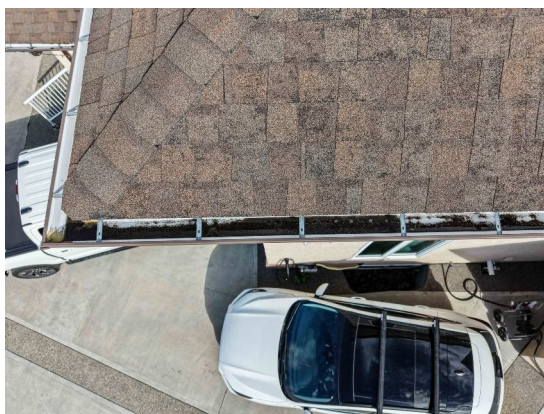
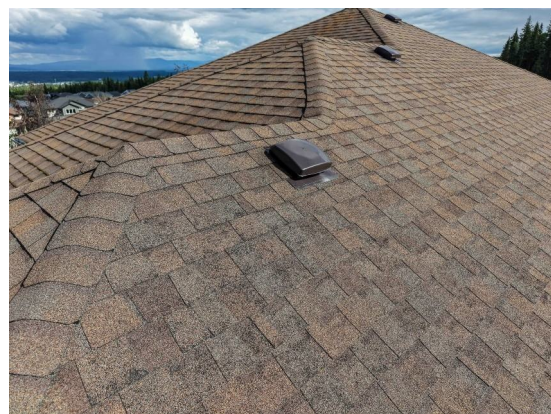
Visible surface wear consistent with shingle granule loss was observed across multiple roof faces.

Review with a certified roofing contractor or roof inspector to determine an appropriate course of action.

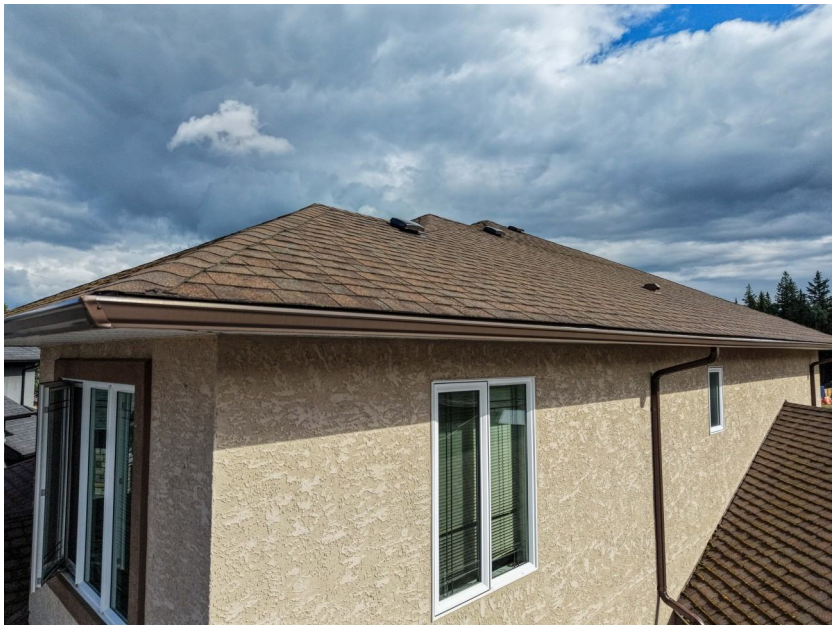
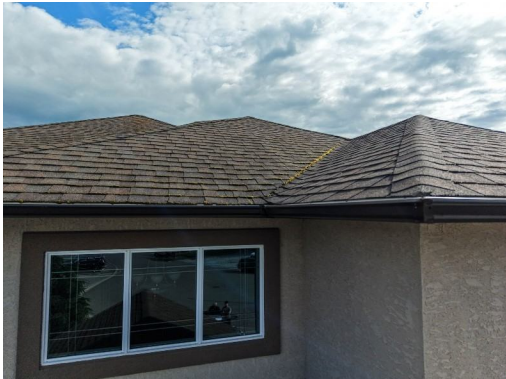
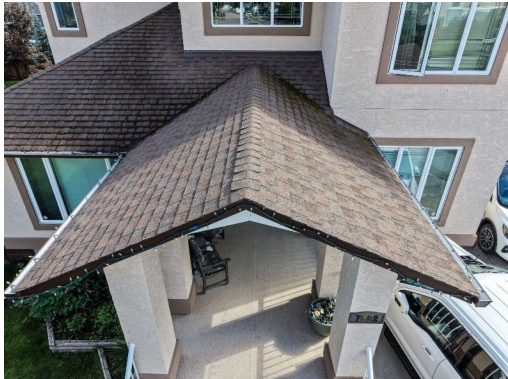
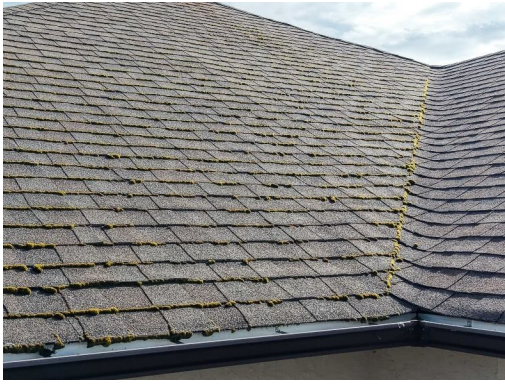
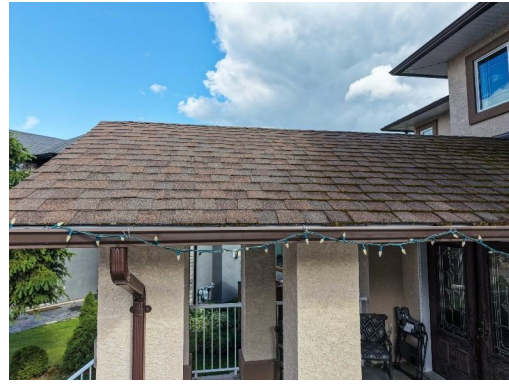
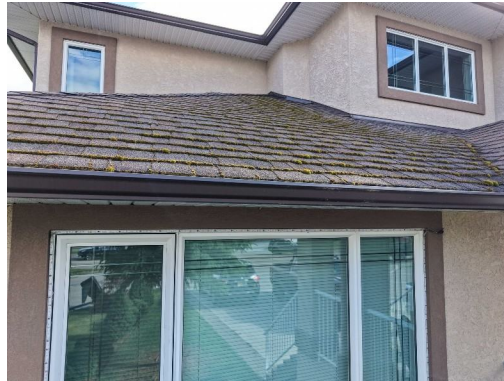
**Observation**  
No obvious shingle curling was observed in the captured imagery.

**Recommendation**  
Continue to monitor as part of routine/annual roof maintenance.

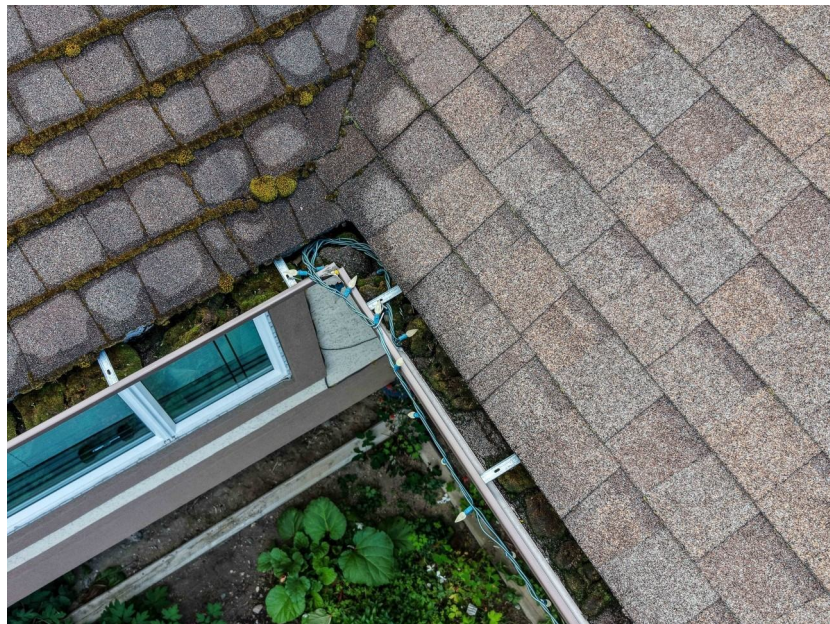
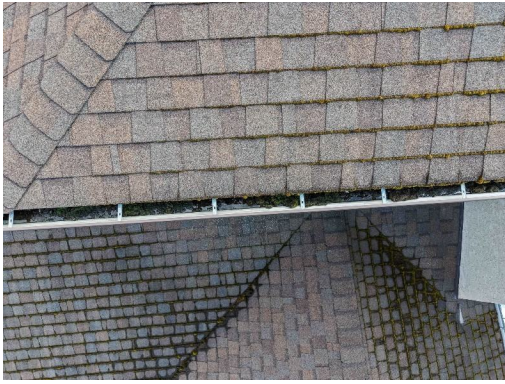
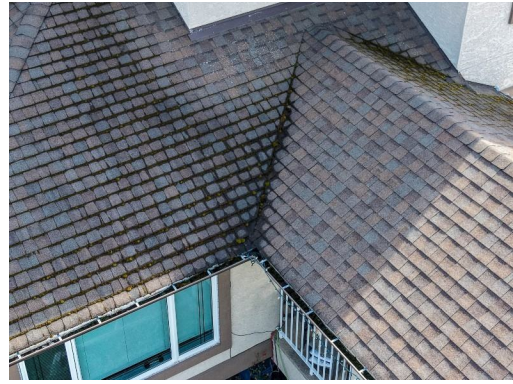
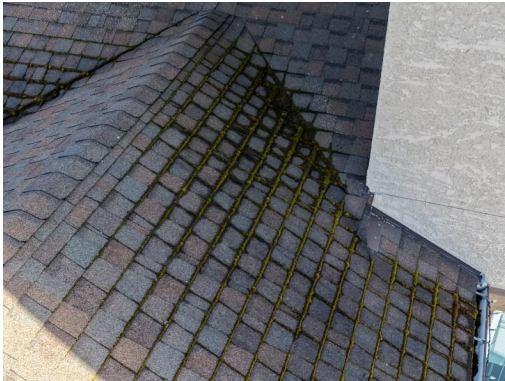
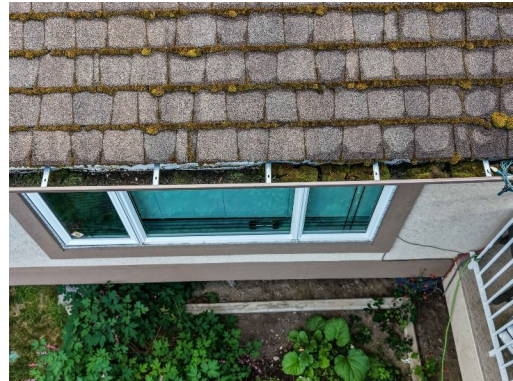
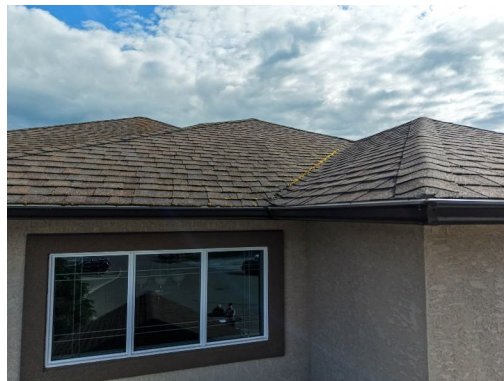
Moss growth was observed on most of the north roof faces, specifically along north-facing valleys and along shingle/shingle overlap areas.

Moss growth may retain moisture and create a moisture infiltration risk. Include moss removal and treatment as part of routine/annual roof maintenance.

Once the roof has had time to dry after the recent rain, monitor for evidence consistent with retained moisture and review with a certified roofing contractor or roof inspector to determine an appropriate course of action.

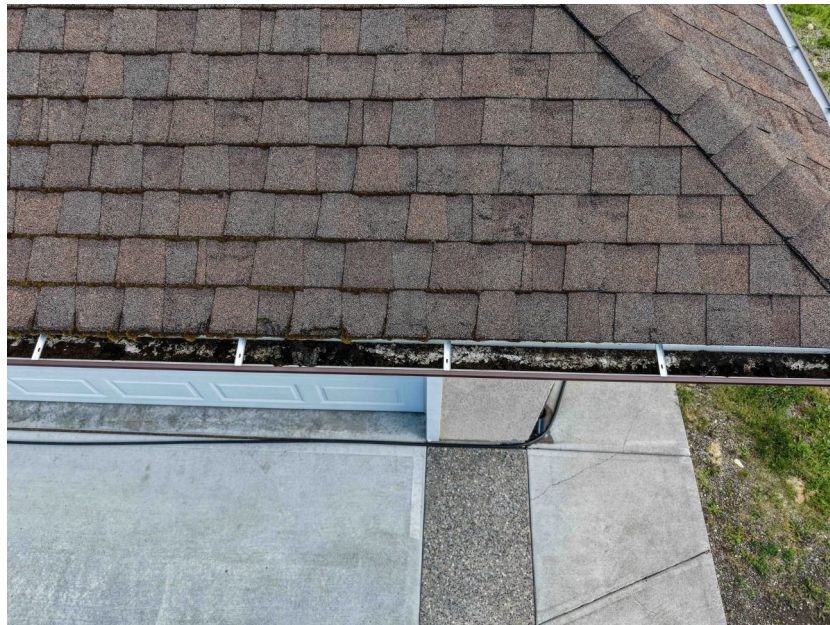
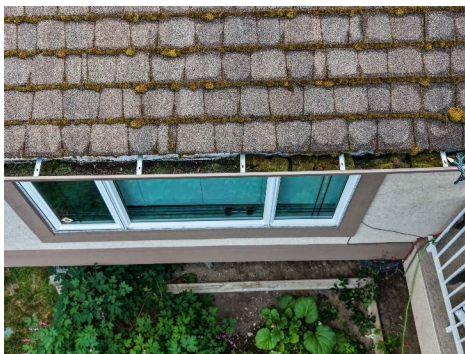
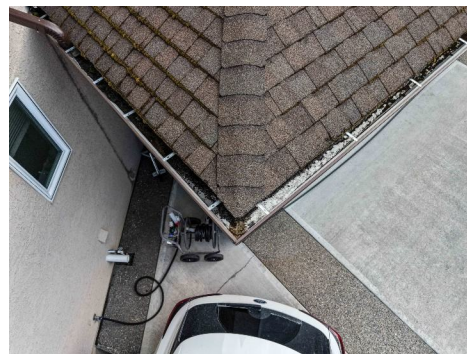
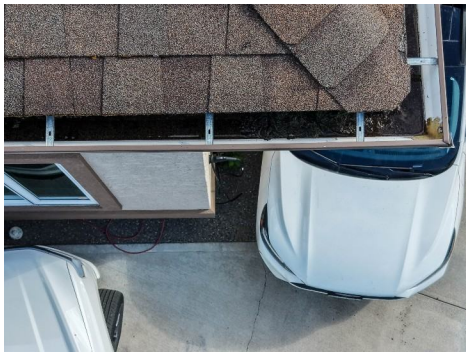
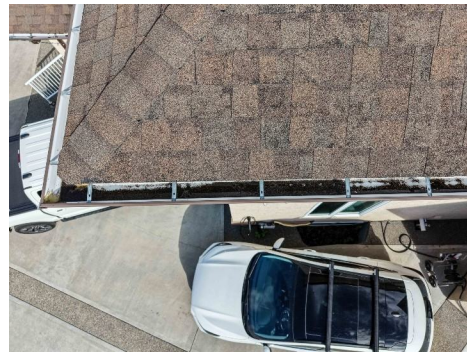
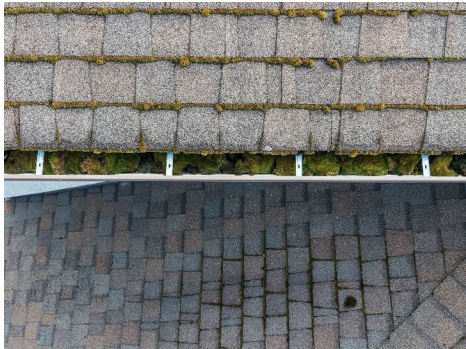
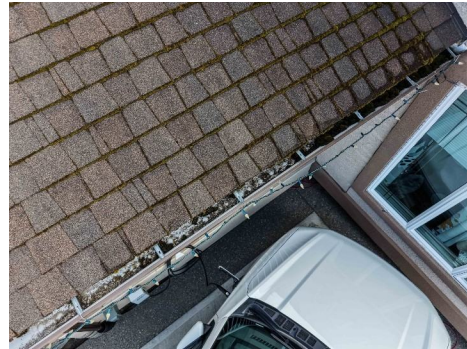
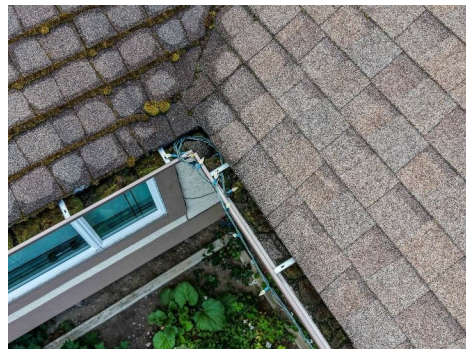
Drainage gutters across most of the north roof slopes, from the garage following around to the northeast corner of the residence, were observed to have extensive moss growth. Some shingle granule accumulation was also observed in these areas. Some gutter sections appeared to contain standing water in areas where moss and debris buildup was visible. Visible downspout components appeared intact.

Restricted drainage may hold runoff against roofing materials and may increase moisture-related risk. Add drainage gutter cleaning to routine/annual roof maintenance to help maintain proper flow of runoff.

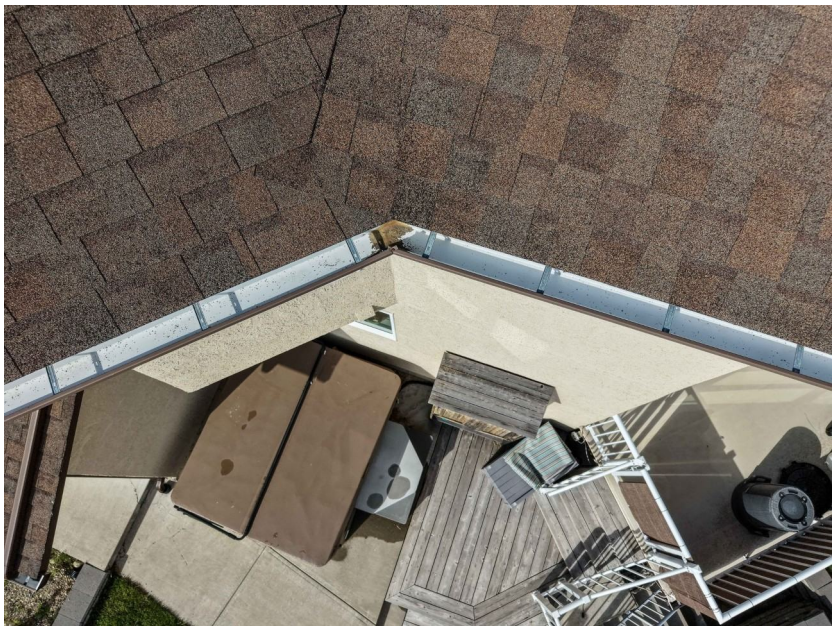
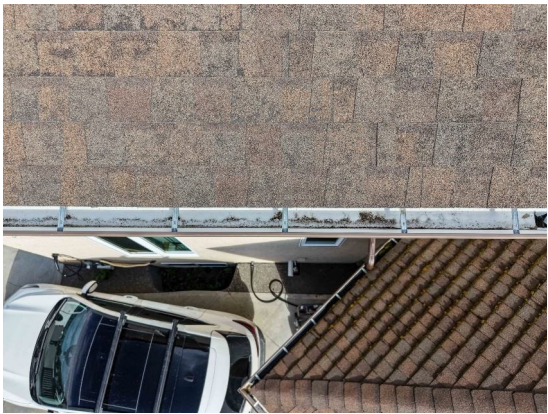
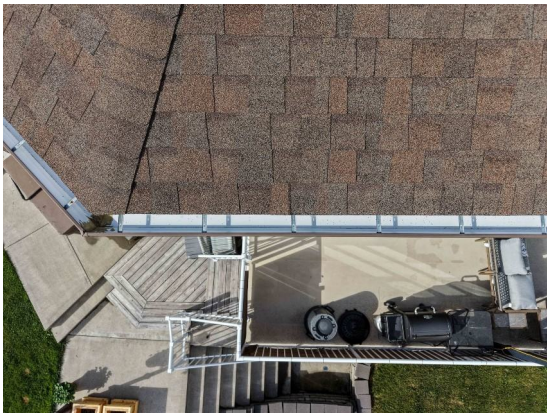
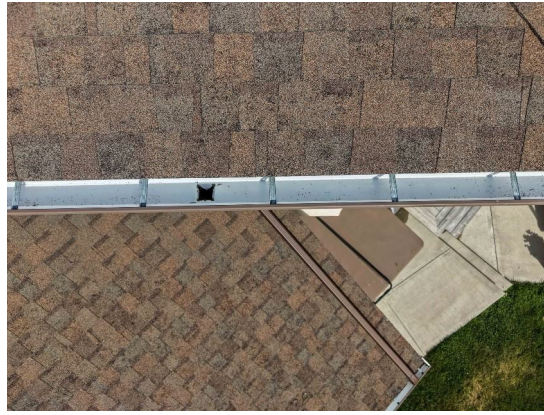
**Observation**  
Drainage gutters across the southern slopes of the roof appear visibly clear and in good condition.

**Recommendation**  
Monitor drainage gutters for buildup and clean annually as part of routine/annual roof maintenance.
